AIRCRAFT ACCIDENT REPORT

UNCONTROLLED COLLISION WITH TERRAIN
AIR TRANSPORT INTERNATIONAL
DOUGLAS DC-8-63, N782AL
KANSAS CITY INTERNATIONAL AIRPORT
KANSAS CITY, MISSOURI
FEBRUARY 16, 1995

**Adopted: August 30, 1995
Notation 6538A**

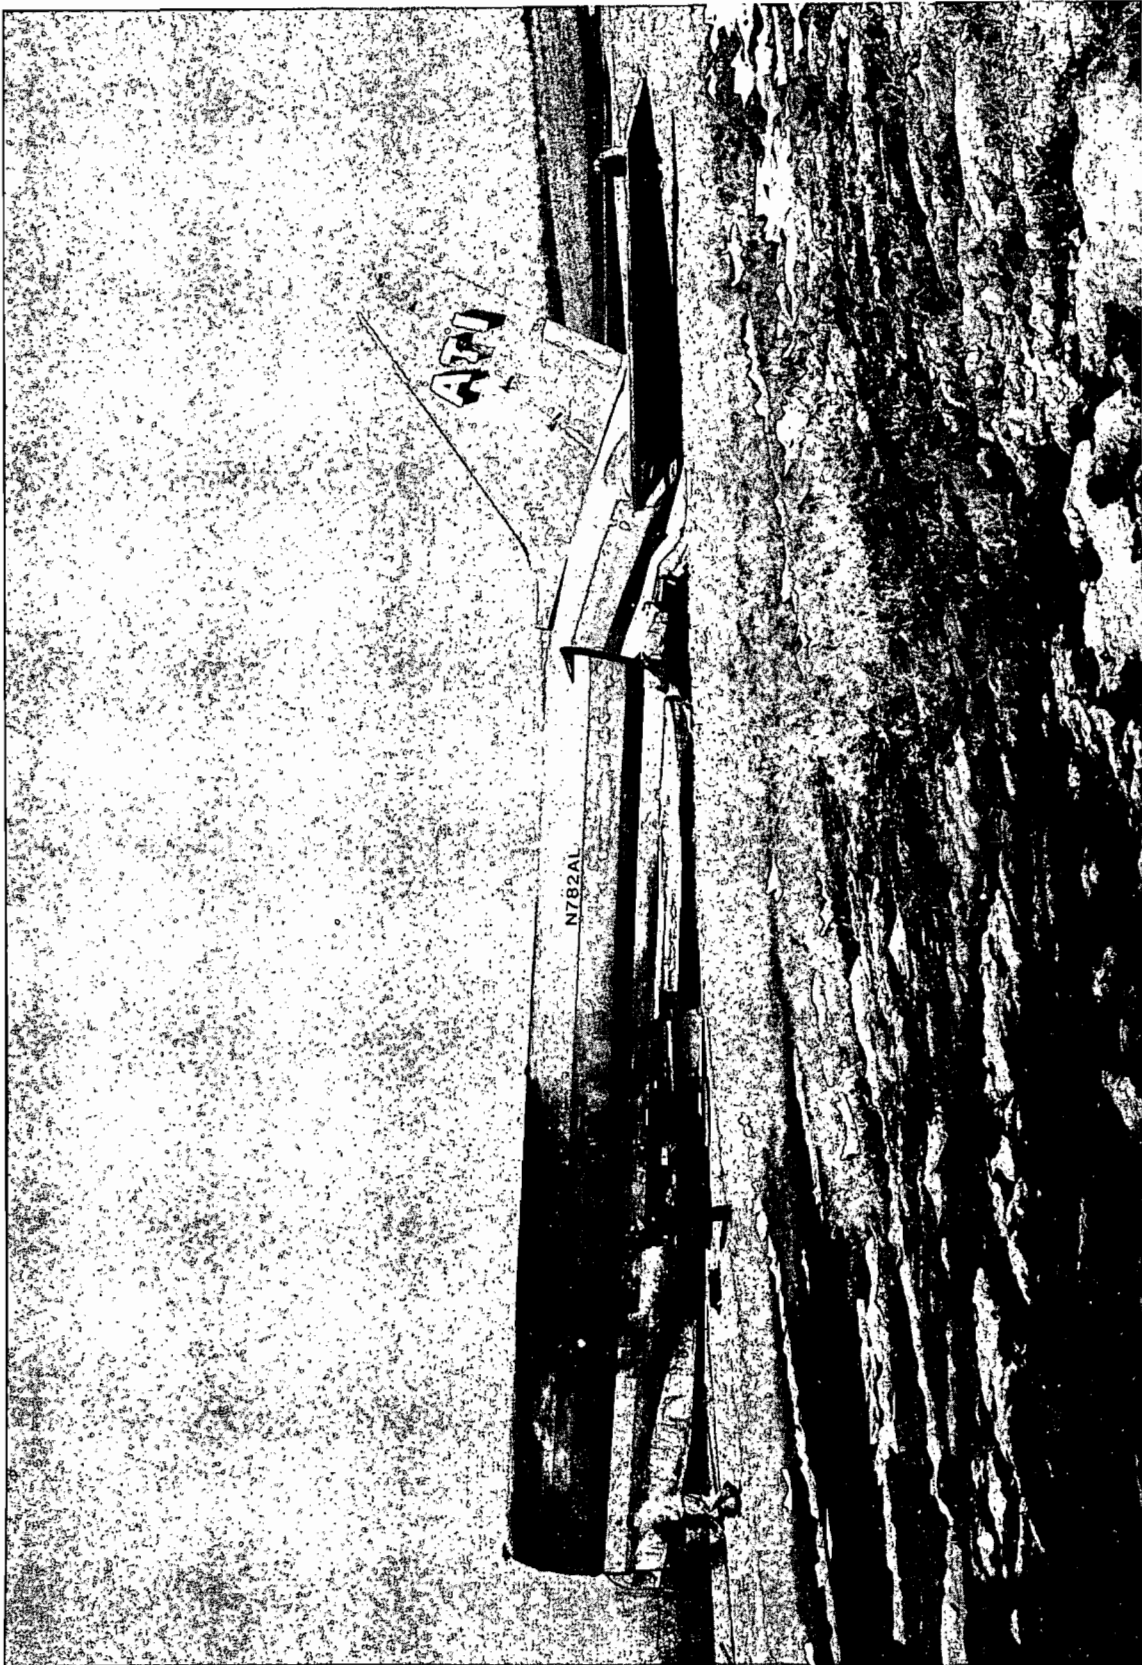
Figure 1.--Ground view of wreckage.

nose high attitude during rotation," and he observed a "bright yellowish-orange ball of fire from the exhaust of the No. 2 engine." He then saw the airplane enter a "slowly increasing left bank" just before impacting the ground. See figures 1 and 2.

The cockpit and forward fuselage suffered severe impact damage. The upper cockpit structure remained recognizable, but the lower cockpit structure, radome, and fuselage were mostly broken into smaller pieces. The upper, forward section of the cockpit was found upside down, and the front windows were shattered.

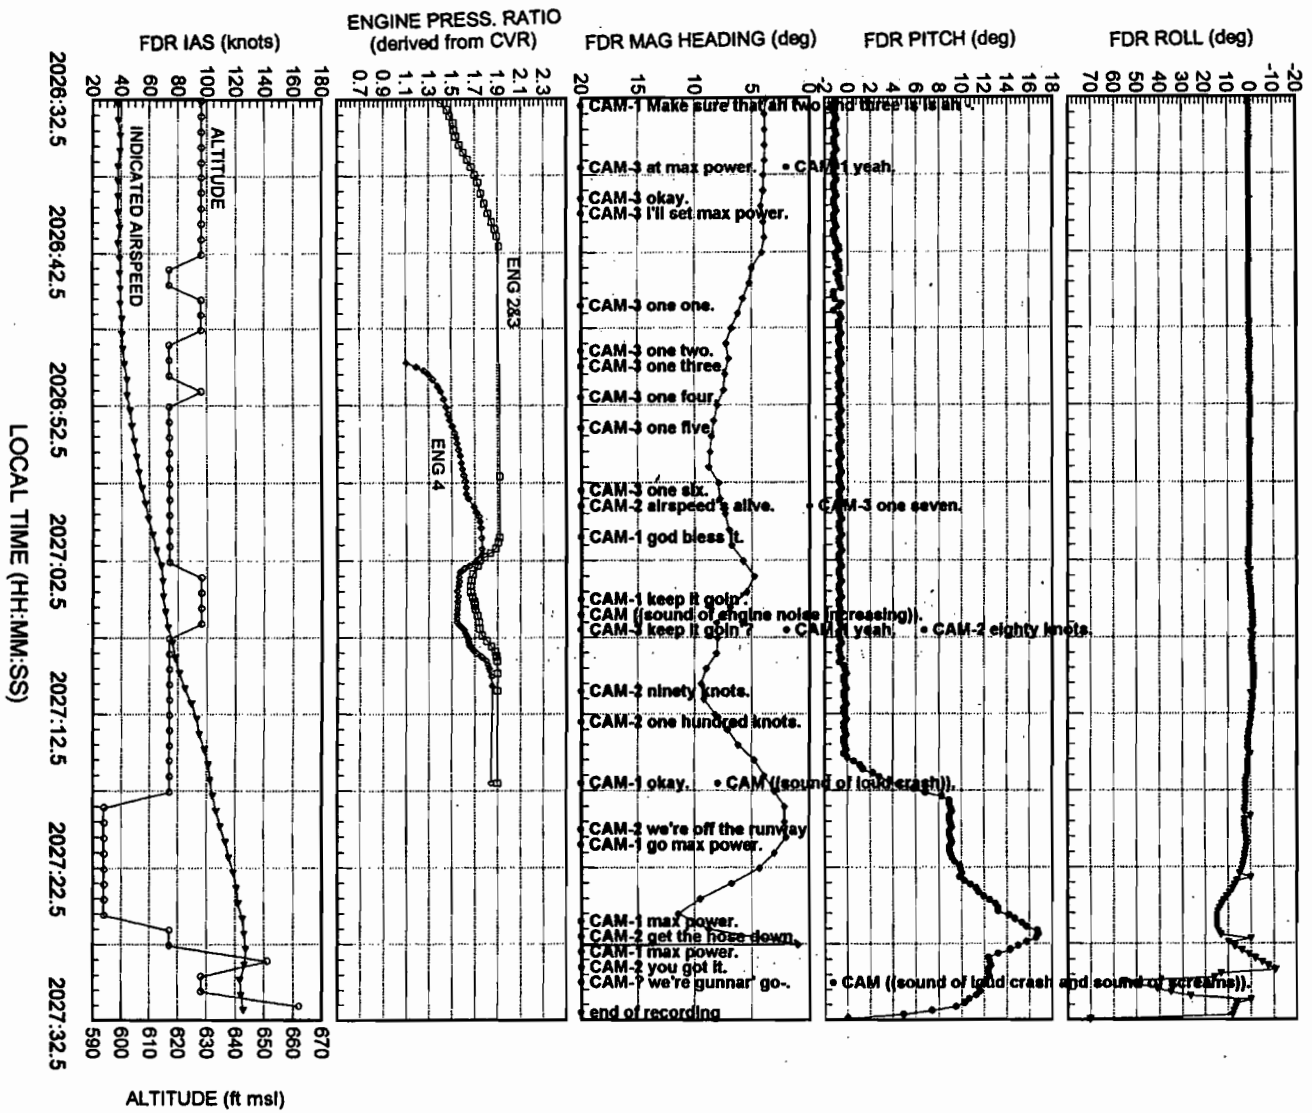
Figure 3.--FDR/CVR presentation.

The airplane was equipped with a Fairchild Model A100 cockpit voice recorder (CVR), S/N 2325, and a Sundstrand digital flight data recorder (DFDR), P/N 980-4100-60US, S/N 7768. Both units were mounted in a compartment in the aft fuselage below the cargo bay floor. Both units were found separated from their mounts. Only minor dents in the outer cases were seen. There was no evidence of fire damage. DFDR information is included in figure 3, and a transcript of the CVR recording is included in Appendix B.

microphone keying. The DFDR was upgraded from five parameters to eleven parameters by Aircraft Systems and Manufacturing, Inc. Documentation of this upgrade was found to be incomplete and difficult to interpret. Documentation for elevator position was not sufficient to convert the raw values to engineering units. Engine rpm data was spurious and unusable. All engine data for this accident was derived from the CVR sound spectrum.

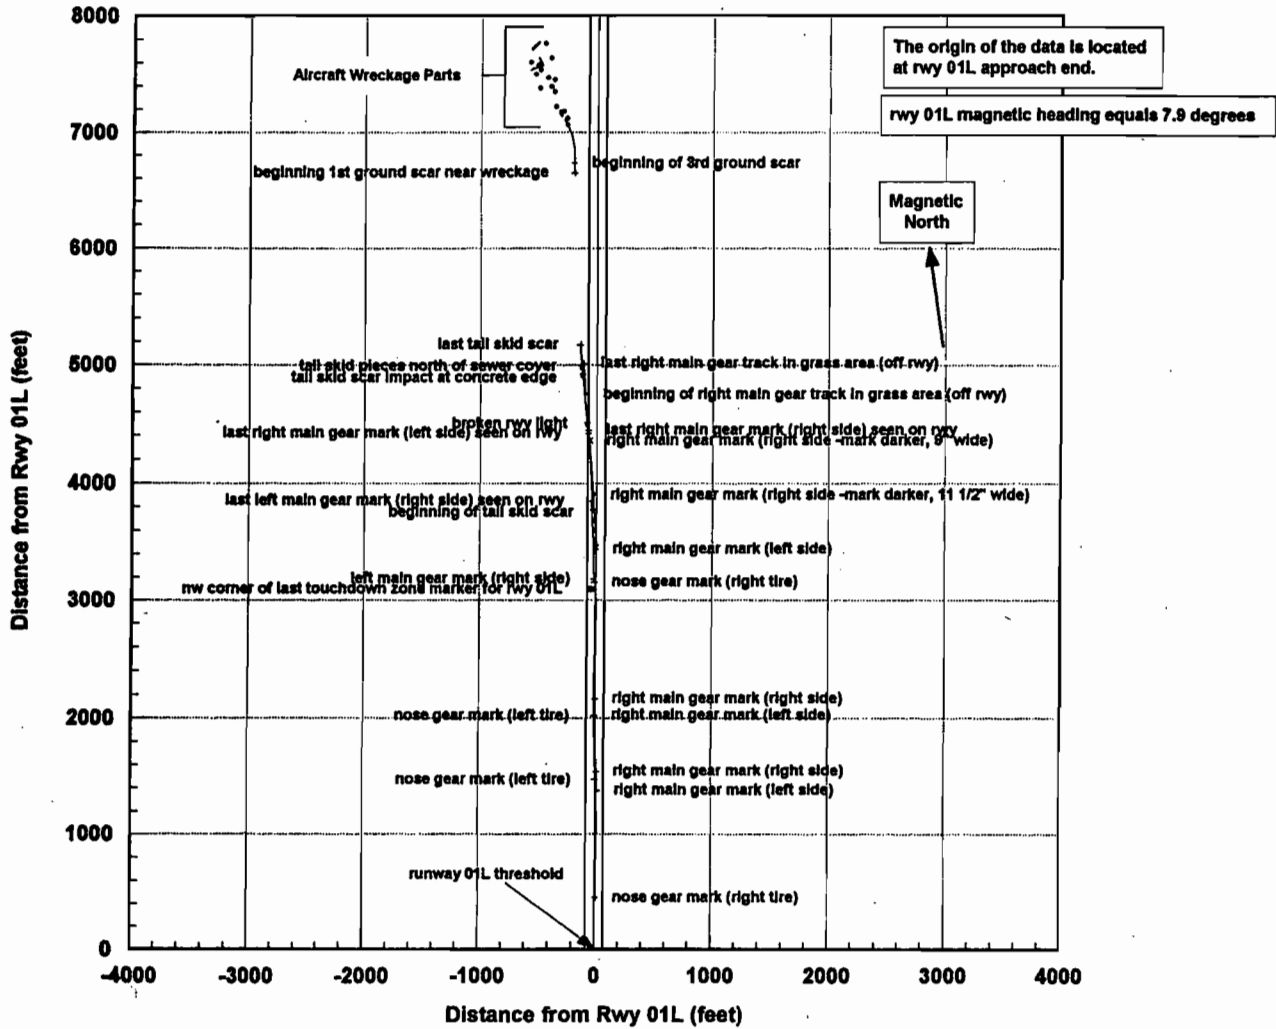
Figure 4.--Ground scars, ground marks, and wreckage.

Some marks attributed to the rejected takeoff were consistent with skid marks from the nose landing gear (NLG) tires. No other tire marks from the rejected takeoff were observed. The first evidence of tire marks was observed on the runway centerline 590 feet from the threshold of runway 1L. The marks

The runway marks attributed to the airplane's second takeoff attempt were consistent with skid marks from the NLG and main landing gear (MLG) tires. Marks in the grass from the right MLG tires were also documented, as were marks on the runway and in the ground adjacent to the runway from the tail skid. The first surveyed tire mark was from the right NLG tire and was located 9 feet right of centerline and 451 feet from the threshold. The tail skid mark began 29 feet left of centerline and 3,779 feet from the threshold. Several pieces of the tail skid casting and fairing were found along the tail skid ground scar. The ground scar ended 144 feet left of centerline and 5,174 feet from the threshold. This was determined to be the takeoff point of the airplane. No additional ground scars or airplane parts were documented until the beginning of the ground scars at the main wreckage site.

Several ground impact scars, containing pieces of left wing, were observed near the main wreckage site. The first of these ground scars began 1,470 feet from the end of the tail skid scar. Fuel was spilled throughout the area of the initial ground scars, and most of the grass in this area was burned. A large trench began approximately 300 feet from the initial ground scar. The trench was generally oriented along a magnetic heading of 350 degrees, although it curved to the west slightly.

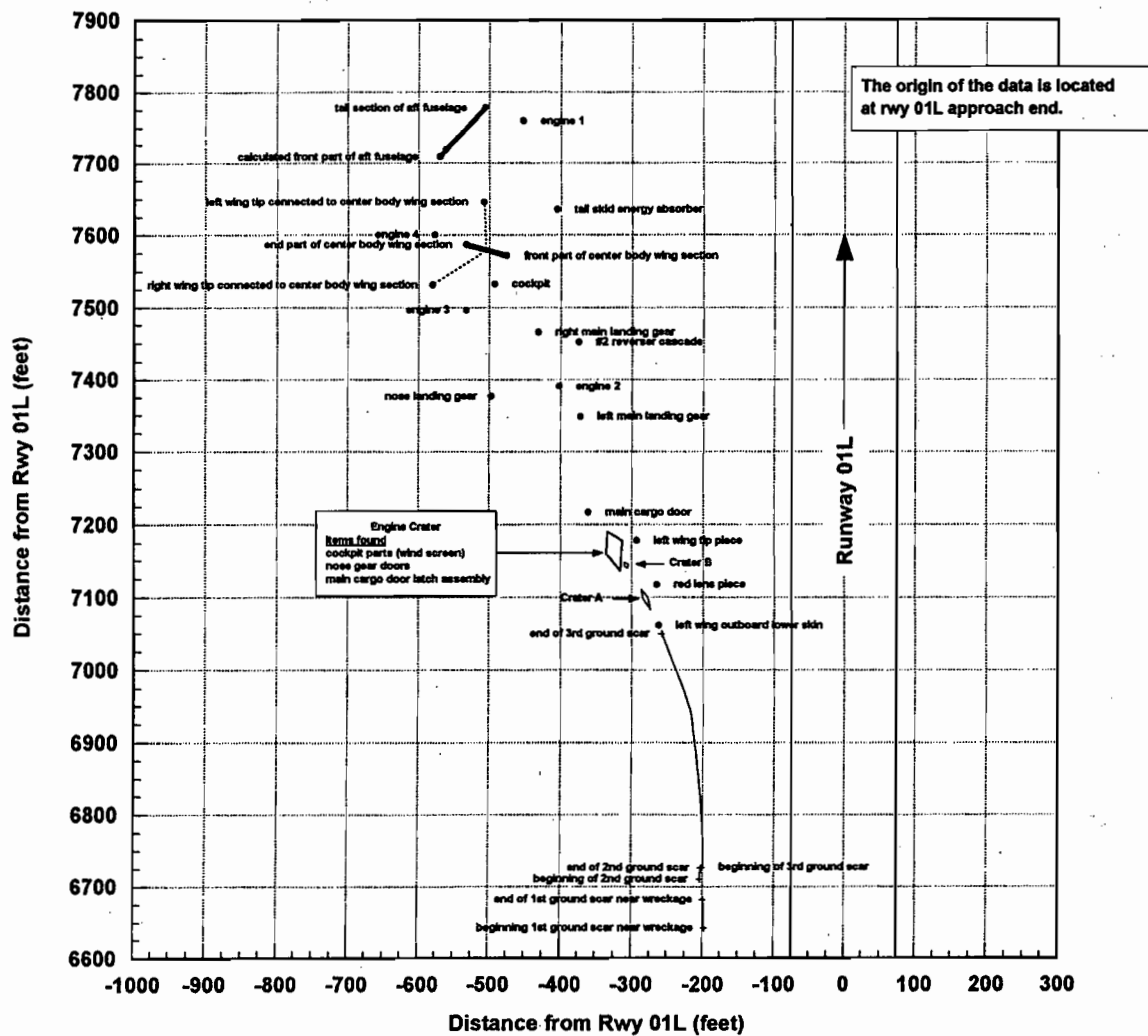
Figure 5.--Ground scars and wreckage.

A large crater was located beyond the trench. Pieces of cockpit side window, a nose landing gear door, forward fuselage, a main cargo door latch assembly, and pieces of the No. 2 engine were found in and around the crater. A 10-foot section of the left wing tip was located near the crater. This piece had been heavily damaged by fire, and the outboard tip structure was mangled and bent. Also found just beyond the crater were a 19-foot-long piece of outboard left lower skin and most of the main cargo door. Examination of the door revealed that it was latched and locked. Pieces of red lens were found between the initial left wing

ground scars and the left wing tip.

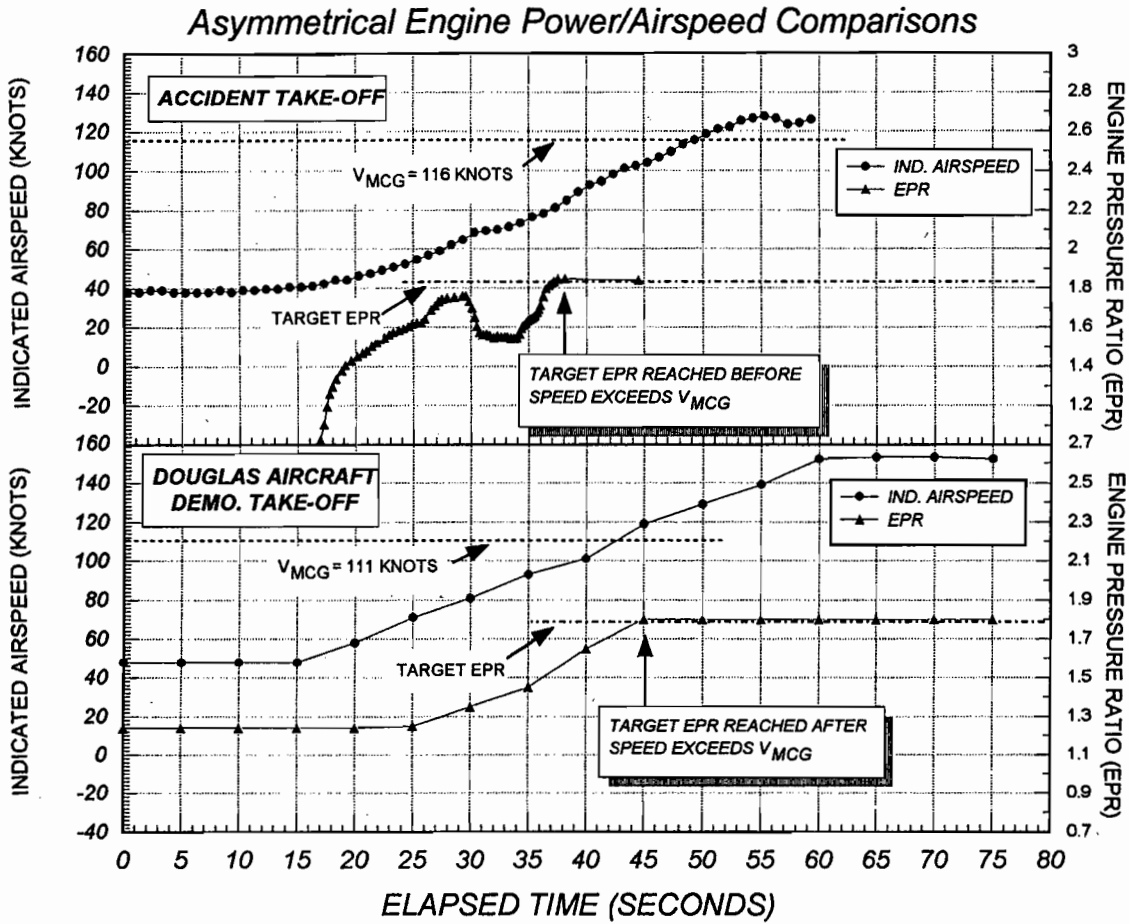
Figure 7.--No. 4 engine EPR/IAS comparison.

The high rate of asymmetric throttle application by crewmembers in both the attempted takeoffs precluded successful completion of the maneuver. However, the Safety Board believes that even with the proper application of asymmetric throttle during a three-engine takeoff, the margin of safety is quite small. The procedure now calls for arriving at full takeoff power on the asymmetric engine at the computed V_{mcg} to provide for the minimum possible takeoff roll. A properly executed three-engine takeoff also entails full rudder application at the computed V_{mcg} . Any adverse crosswind condition, for instance, would place the flightcrew in a position in which they could not have full control of the airplane due to a loss of rudder authority. In addition, it is very difficult to time the throttle application to arrive at full power at exactly the computed V_{mcg} given the spool-up lag inherent in turbine engine operation.

A flightcrew, therefore, invariably reaches full asymmetric power early, and accepts a certain loss of directional control, or reaches full asymmetric power late, and accepts a longer takeoff roll. The Safety Board considers the latter to be the safer course of action, and believes that manufacturers should revise one-engine inoperative takeoff procedures to provide adequate rudder availability for correcting directional deviations during the takeoff roll compatible with the achievement of maximum asymmetric thrust at an appropriate speed greater than ground minimum control speed. Performance figures and runway requirements considering these factors should also be determined.
